# Manhole Inspection Summary

Manhole # S11Y\_\_023MH

Insp Date: **4/11/08 9:21 AM**

**Location** Address: **S. Caton Ave**

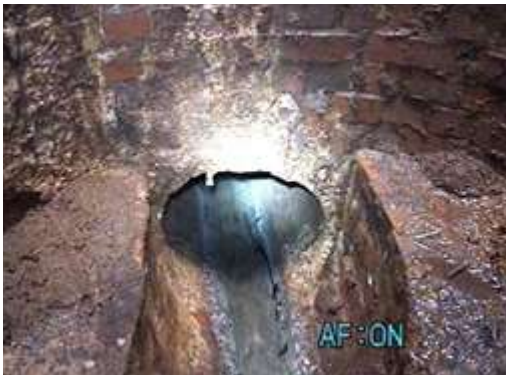
Defect 4

Infiltration: ☐ None ☐ Joint ☐ Cracks ☐ Mortar ☐ Roots ☒ **Wall**

barrel infiltration

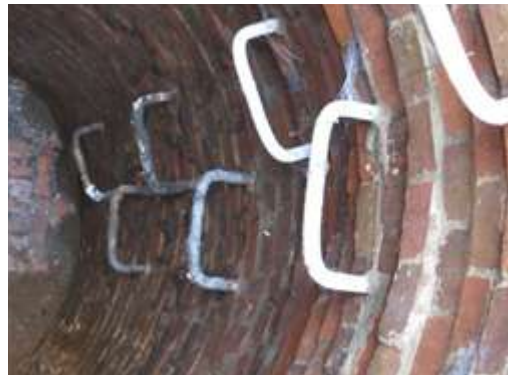
Defect 2

**Steps** Count: **7** Missing: **0** ☒ **Corroded**

Corroded steps

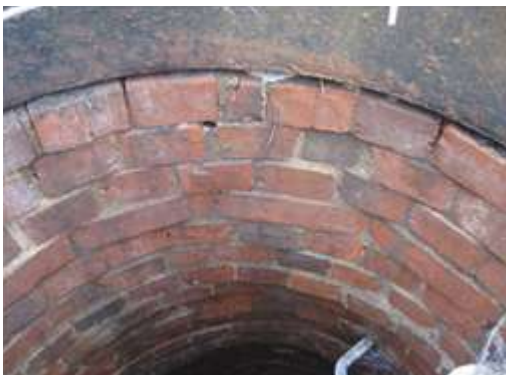
Defect 1

Condition: ☐ Sound ☐ Cracked ☐ Root Intrusion ☒ **Loose Brick** ☐ Deteriorated

Loose bricks and mortar under frame

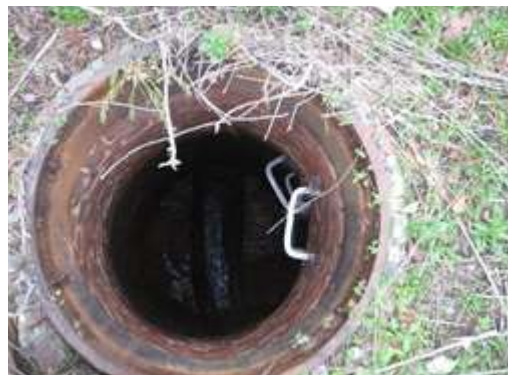
Defect 3

**Frame** Offset: **1** (in.) Condition: ☒ Sound ☐ Cracked ☐ Leaks

frame offset

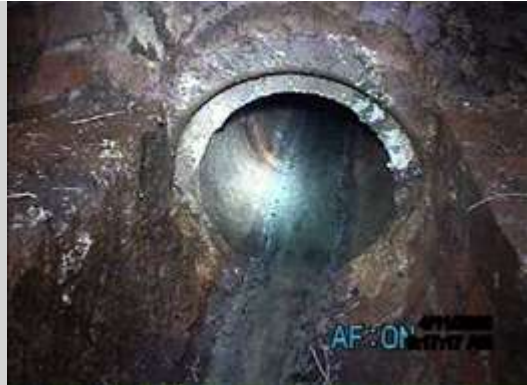
12 O'Clock Outflow

Pipe Height: **15.6** (in.) Rod and Bar (Angled)  
Pipe Material: **Clay** ☐ Pipe Lined  
Invert Depth: **12.76** (ft.) Flow Characteristics: **Fast**  
Deposits: ☒ None ☐ Mud ☐ Sludge ☐ Debris ☐ Grease  
Silt Depth: **0** (in.) Deposits Extent:  
Infiltration: **Evidence** Pipe Seal Cond: **Unknown**

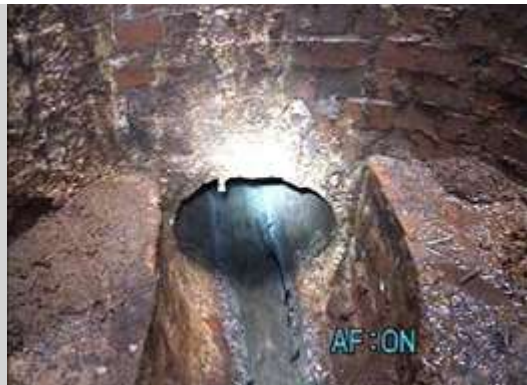
6 O'Clock Inflow

Pipe Height: **13.2** (in.) Rod and Bar (Angled)  
Pipe Material: **Clay** ☐ Pipe Lined  
Invert Depth: **12.48** (ft.) Flow Characteristics: **Fast**  
Deposits: ☒ None ☐ Mud ☐ Sludge ☐ Debris ☐ Grease  
Silt Depth: **0** (in.) Deposits Extent:  
Infiltration: **Evidence** Pipe Seal Cond: **Unknown**
